Test Report No. SHAEC2205394635 Date: 08 Jun 2022 Page 1 of 4

Sample Name : MV6J-01R Material No. : MV70-01R

Test Requested: Selected test(s) as requested by the client.

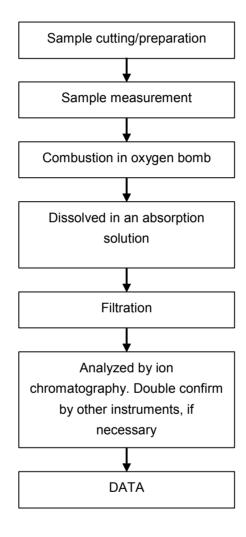
Halogen Testing (oxygen bomb) Flow Chart

Test Method: With reference to EN 14582: 2016, analysis was performed by IC.

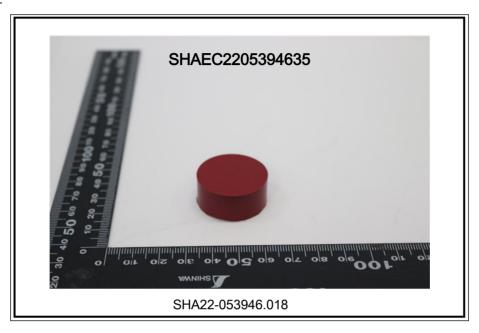
Sample photo:

Specimen No. SGS Sample ID Description SN1 SHA22-053946.018 Red solid
