## Test Report

No.: SHAEC24006929935

Sample Name: V6E01N

## Asbestos

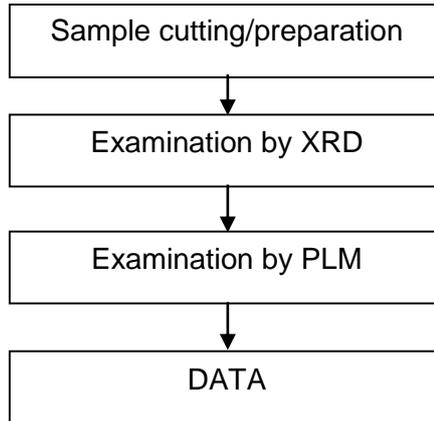
Asbestos Testing Flow Chart

Test Method: With reference to NIOSH 9000:2015 and ISO 22262-1:2012, analysis was performed by XRD/PLM.

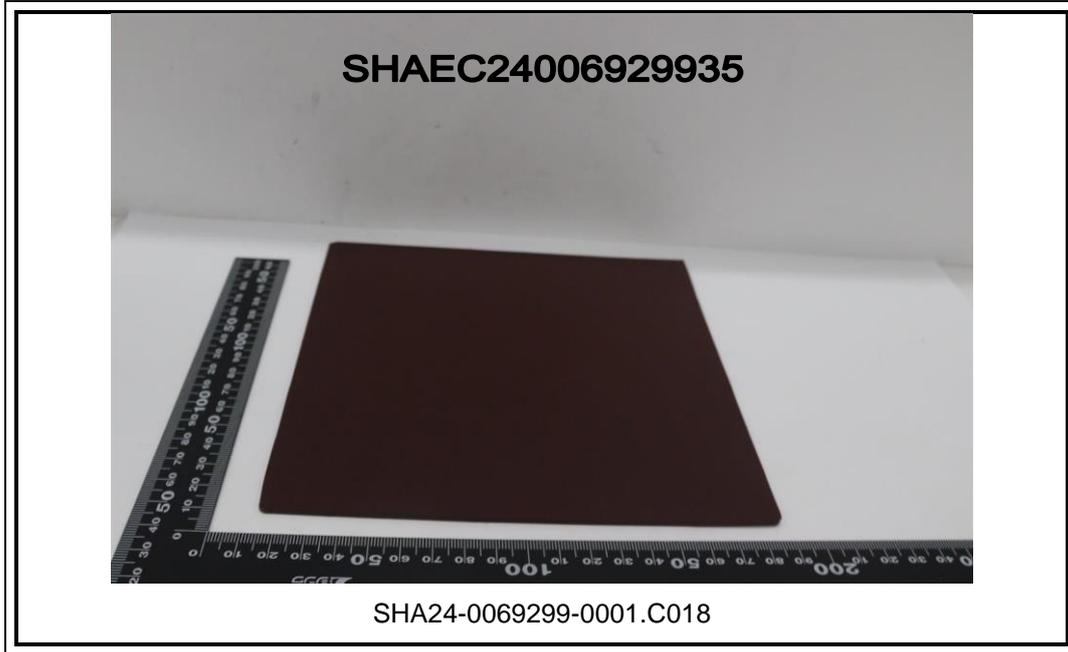
Sample Photo:

SN ID	Sample No.	SGS Sample ID	Description
SN1	A18	SHA24-0069299-0001.C018	Brown rubber
