## Test Report

No.: SHAEC24006929929

Sample Name: N6J01B

## Halogen

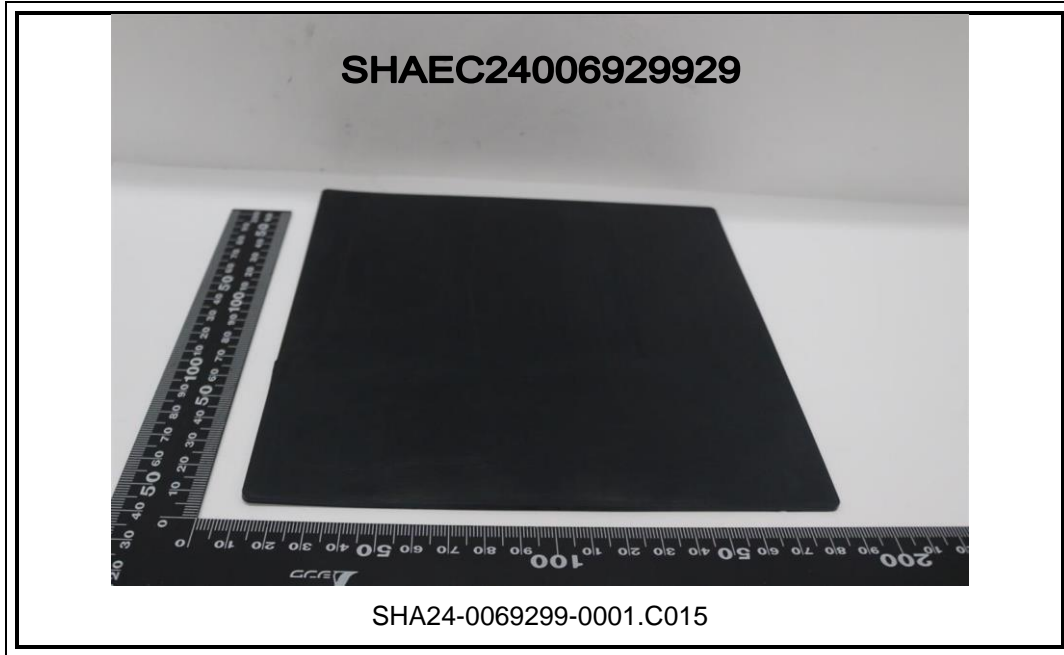
Sample Photo:

SN ID	Sample No.	SGS Sample ID	Description
SN1	A15	SHA24-0069299-0001.C015	Black rubber
